# CITY OF BINGEN

## DISTRIBUTION SYSTEM LEAKAGE STUDY

G&O #11248  
JULY 2012

**Gray & Osborne, Inc.**  
CONSULTING ENGINEERS

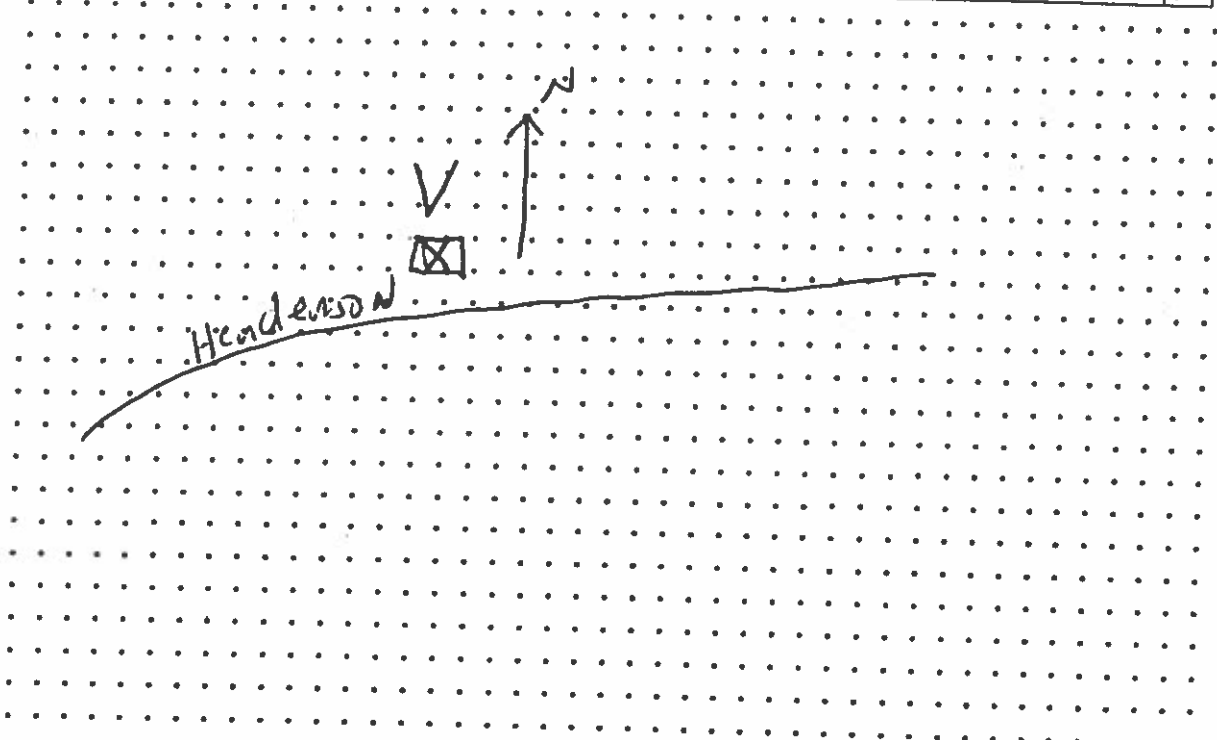
LOCATION: SPS LUMBER MAP NO. \_\_\_\_\_ DATE: 7-12-10

A leak was detected with the detection equipment on an abandoned 1-1/4-inch line on Henderson Drive on the east end of the City. The valve on this line was operated and does not shut off completely. Leak Masters recommends replacing this portion of the water line and the main valve. Alternatively, a valve could be installed directly upstream of this location because there are no additional services off of the 1-1/4-inch line. Yearly leakage at this location could amount to approximately 3 MG according to the estimates provided by Leak Masters.

REMARKS:  
 CLOSED CURB / METER VALVE, LEAK STOPPED     TIGHTENED HYDRANT OPERATING NUT, LEAK STILL EXISTS  
 LEAK LOCATED AT CURB / METER PIT VALVE     TIGHTENED HYDRANT OPERATING NUT, LEAK STOPPED  
 NOT SURE OF LINE CONFIGURATION     LEAK LOCATED AT SERVICE CORPORATION INTO MAIN LINE  
 ACCESS TO SYSTEM CONTACTS LIMITED     ADDITIONAL ACCESS REQUIRED TO LOCATE LEAK  
 Heard Leak noise on old abandoned  
1 1/2" line to old mill - old valve leaking  
BT. Does not shut off.

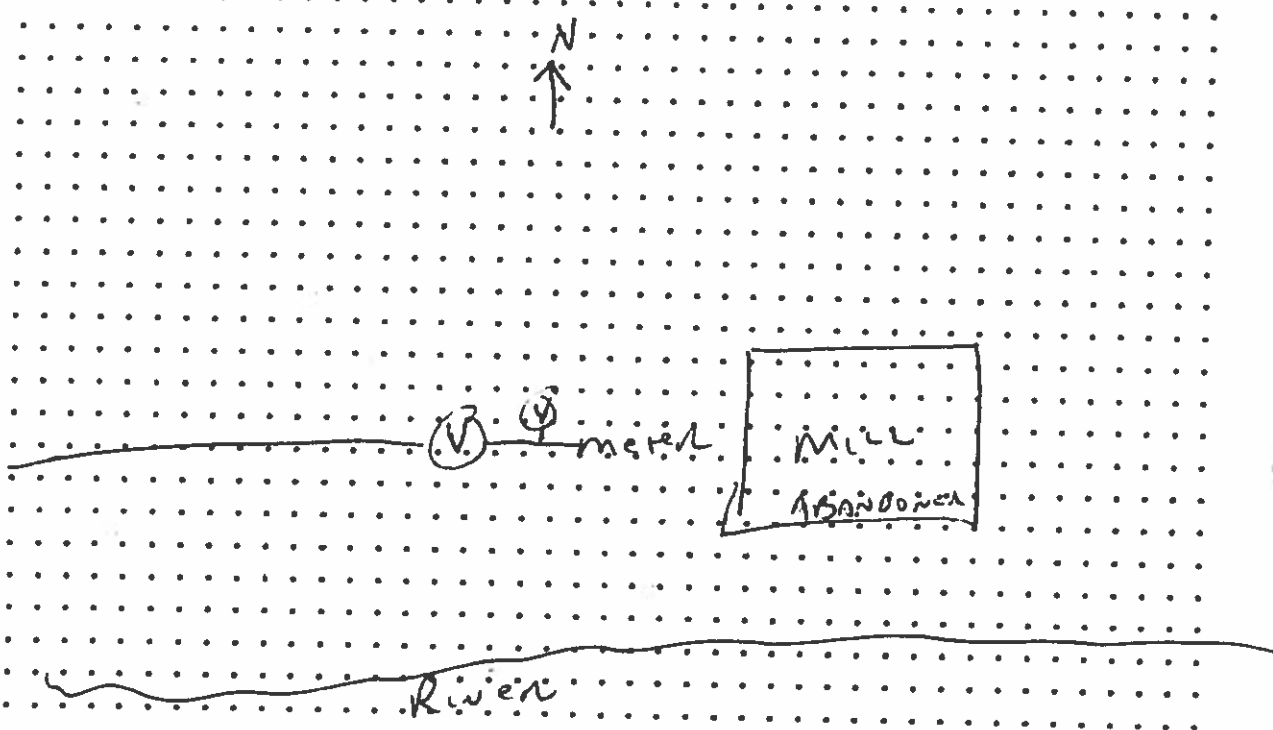
LOCATION: \_\_\_\_\_ MAP NO. \_\_\_\_\_ DATE: 7-12-10

REMARKS:  
 CLOSED CURB / METER VALVE, LEAK STOPPED     TIGHTENED HYDRANT OPERATING NUT, LEAK STILL EXISTS  
 LEAK LOCATED AT CURB / METER PIT VALVE     TIGHTENED HYDRANT OPERATING NUT, LEAK STOPPED  
 NOT SURE OF LINE CONFIGURATION     LEAK LOCATED AT SERVICE CORPORATION INTO MAIN LINE  
 ACCESS TO SYSTEM CONTACTS LIMITED     ADDITIONAL ACCESS REQUIRED TO LOCATE LEAK  
Reese mill - main valve - loud leak noise may be valve not shutting properly. Operated valve but noise continued

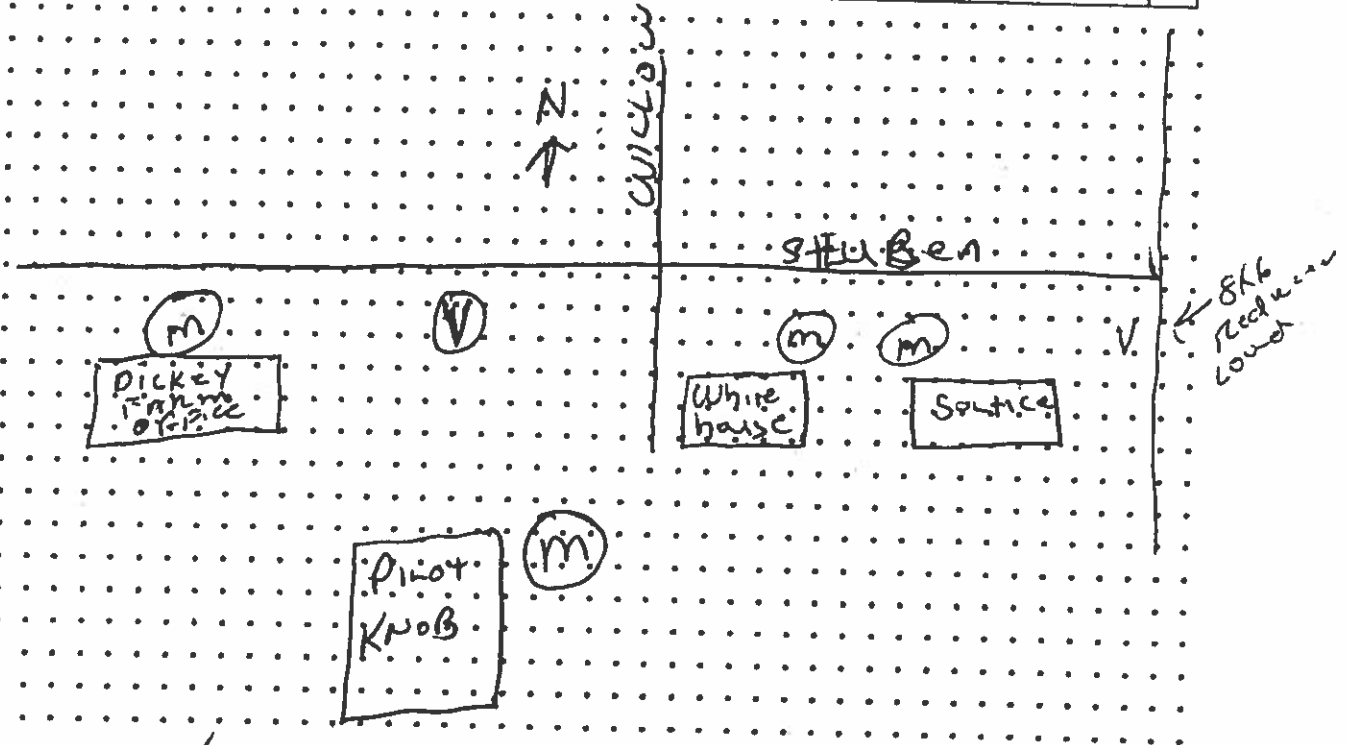
LOCATION: \_\_\_\_\_ MAP NO. \_\_\_\_\_ DATE: 7-12

REMARKS:  
 CLOSED CURB / METER VALVE, LEAK STOPPED     TIGHTENED HYDRANT OPERATING NUT, LEAK STILL EXISTS  
 LEAK LOCATED AT CURB / METER PIT VALVE     TIGHTENED HYDRANT OPERATING NUT, LEAK STOPPED  
 NOT SURE OF LINE CONFIGURATION     LEAK LOCATED AT SERVICE CORPORATION INTO MAIN LINE  
 ACCESS TO SYSTEM CONTACTS LIMITED     ADDITIONAL ACCESS REQUIRED TO LOCATE LEAK  
 Loud Noises At all three locations  
 Pipe configuration not shown on map - mix of plastic steel copper  
 ONLY contact points are valve and meter services at Bingers

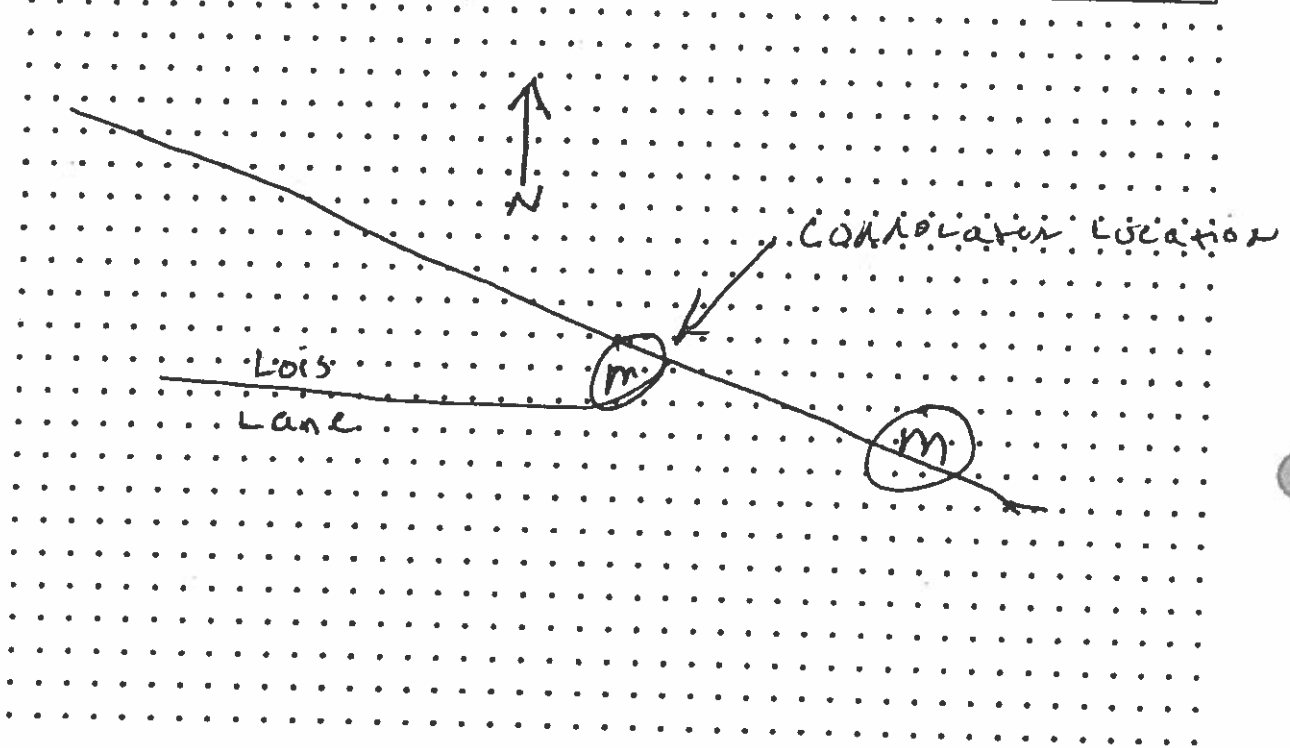
LOCATION: Lois Lane/OAK MAP NO. \_\_\_\_\_ DATE: 7-15-10

Another main leak was located at Lois Lane and Oak on the 2-1/2-inch line that feeds the City from White Salmon. Two leaks were found 1.4 feet and 6.4 feet from this intersection. It is possible that additional leaks were not found on this line due to the extreme traffic noise that interferes with the leak detection equipment. Leak Masters estimates the leakage here could amount to approximately 3 MG. Leak Masters recommends replacing 10 feet of main up the hill from this location.

The last location I heard any leak noise was at Lois lane and oak. This is the line that feeds down the highway from the town next door. It has a PRV at the start of the line and is making a loud noise all the way down the line. This noise is the same as a leak noise. I did run the correlator on this line from the shut off valve at the bottom of the hill up to several services. The correlator did try to lock onto a spot at the corner of lois lane and oak. I ran the correlator from several locations and it came to this point each time. This appears to be an old meter box that has been abandoned. The prv at the start of this line may be interfering with the computer as this makes a lot of noise in the old steel line. Also the traffic noise is extremely severe, making it impossible to ground mic this location.

Heard loud leak noise at abandoned meter on corner of Lois Lane and Oak - ran correlator and it picked up leak noise at this location from 1-4 feet out to 6-11 feet - there is also a lot of background noise from traffic and the PKU at top of hill

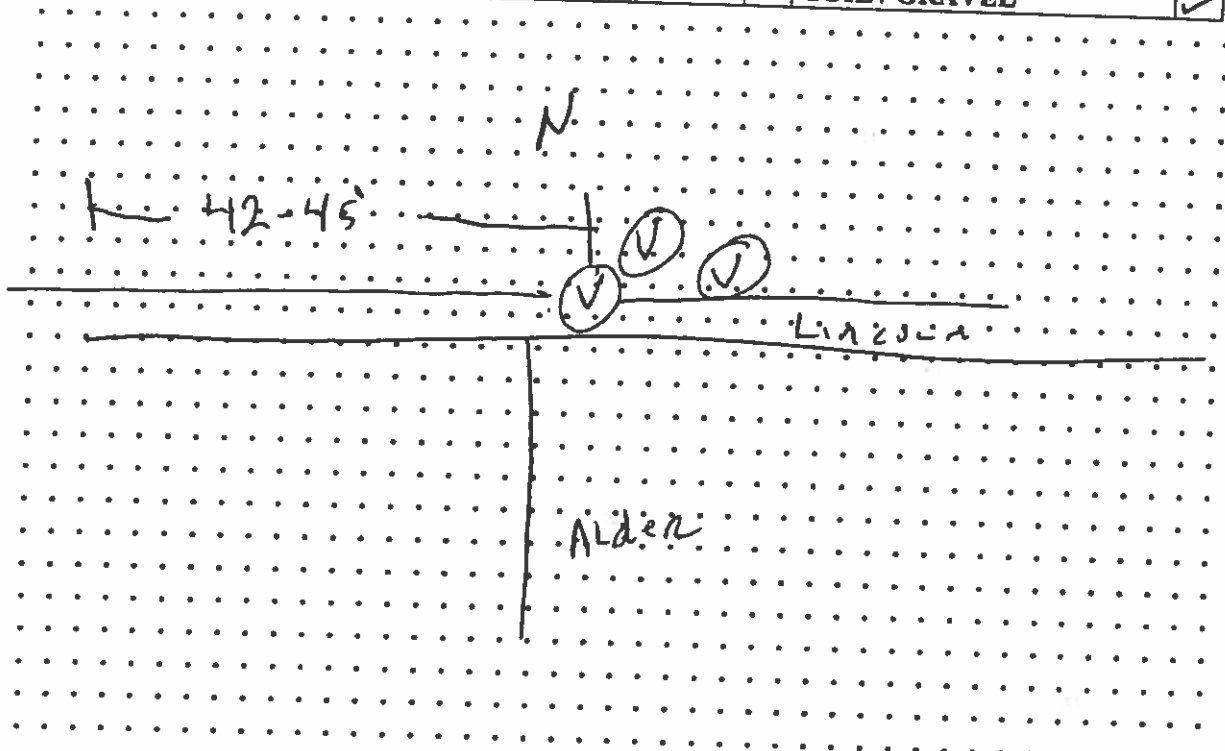
LOCATION: Alder and Lincoln MAP NO. \_\_\_\_\_ DATE: 7-14-10

This leak found was a main leak on a 4-inch steel line at Alder and Lincoln in front of the veterinary clinic. Notes from Leak Masters indicate that three meters off of this line are loud, as well as the valves on each end of the line. A creek runs directly west of this location, and makes it difficult to pinpoint the exact location of the leak with the correlator. Although additional access is required to determine the exact location of the leak, Leak Masters estimates leakage between 5-25 gpm. City staff repaired the leak on this line on August 12, 2010 and estimate 10 gpm has been leaking for several years. It is possible that there are additional leaks in this area that have not been fixed. Gray & Osborne recommends replacing the service meters and valves around this location. Yearly leakage here could amount to approximately 13 MG, based on Leak Masters estimate of 25 gpm.

The third area that I heard a very loud leak noise was at the intersection of Alder and Lincoln just out front of the veterinarian clinic. I could hear noise on the main valve out in front of the clinic and on the services going down the road to the creek, And then a lot of noise in the creek. There is a lot of background noise because of the flowing water in the creek. And having the pipe exposed and up against the large rocks makes it an area that can transmit a lot of background noise. This makes it much harder to get a location with the correlator because of the vibration along the rocks that the pipe is touching. I also listened on the other side of the creek, on the only other valve we could find that was close enough to be able to use as a contact point. It was a lot quieter. Pipe configuration was not clear as the valves that show on your map do not shut off the main. We had to go all the way down several blocks to find the only other valve on the system. I ran the correlator on this line from one side of the creek to the valve in front of the veterinarian clinic and the computer picked a location about 42-45 feet from this valve going towards the creek. I tried another contact point from the creek up to the valve in the road in front of the clinic and came up to within one foot of the previous mark. I did it a third time and it also came up to the same location in the road. I ran the I-mic on the road and could hear noise all along the pipe. This line may have more than one leak in it.

REMARKS:  
 CLOSED CURB / METER VALVE, LEAK STOPPED     TIGHTENED HYDRANT OPERATING NUT, LEAK STILL EXISTS  
 LEAK LOCATED AT CURB / METER PIT VALVE     TIGHTENED HYDRANT OPERATING NUT, LEAK STOPPED  
 NOT SURE OF LINE CONFIGURATION     LEAK LOCATED AT SERVICE CORPORATION INTO MAIN LINE  
 ACCESS TO SYSTEM CONTACTS LIMITED     ADDITIONAL ACCESS REQUIRED TO LOCATE LEAK  
 Corrolator picked up leak noise two times at 42-45' from main valve. - pipe ALSO MAY have more than one break in it - corrolator showed possible other leaks. NOT SURE OF PIPE CONFIGURATION
